## **Assessment of Building Failure: The Case of Saint Thomas's Anglican Church, Akure, Nigeria**

**Fakere, Rufus Adelanke**  
*Ministry of Works, PMB 606, Akure, Nigeria*

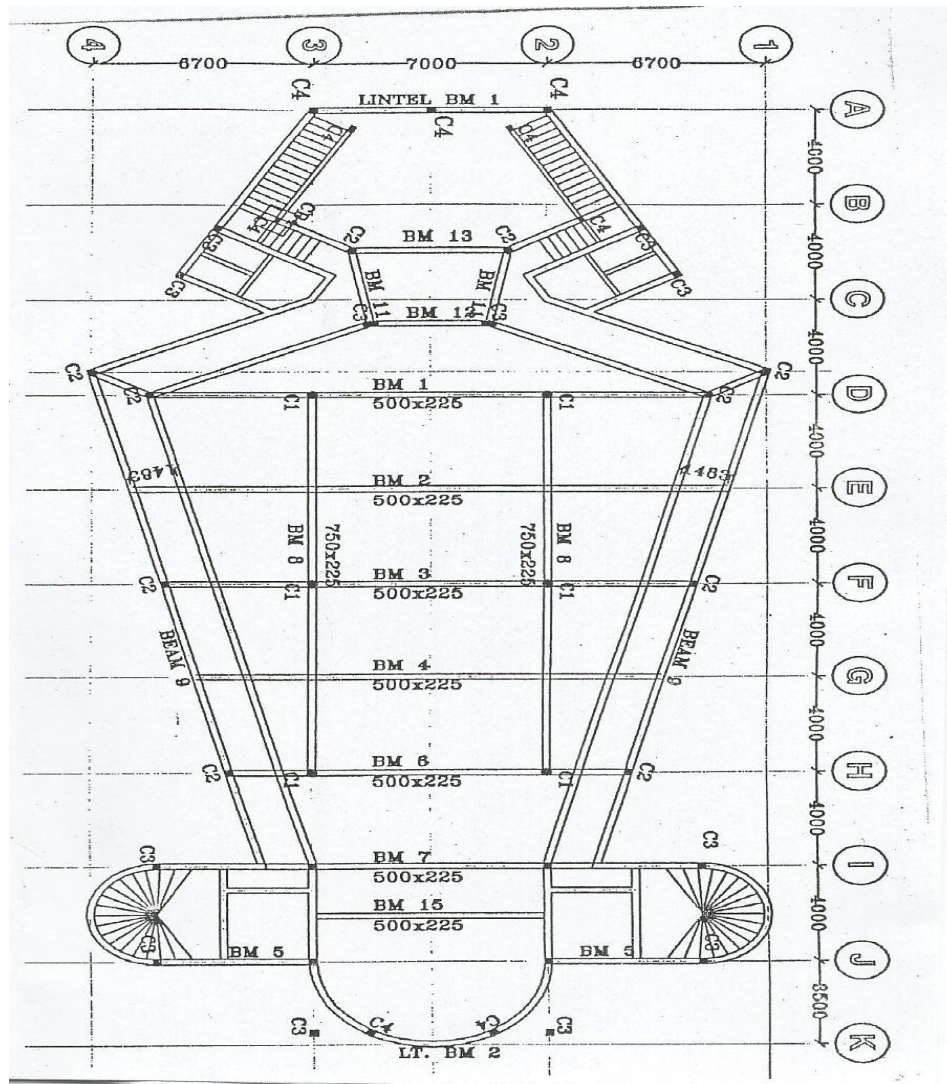
Figure 1: Beams and Columns Layout of the collapse St. Thomas's Church Hall.

layout are shown in figure 1. In Table 4, all the beams checked were normally reinforced except beam eight, which was over-reinforced. An over-reinforced section, which fails in flexural compression, contains more reinforcement than is required to give a balanced section. As the applied moment is increased, the concrete attains its ultimate stress value first, so that by the load is increased continually, since overstress in concrete occurs earlier than in reinforcement any failure is sudden. The depth of the compression zone is increased to a value greater than the balance section. An under-reinforced section on the other hand which fails in flexural tension contains too little reinforcement to permit the balance section to be developed. In under reinforced section, cracks open when the stresses in tension reinforcement attain yield value. The depth of the compression zone is reduced to a value lower than the balance section. In this case since less material is used and besides since when overstressed the reinforcement yields, it is still able to support the yield stress, failure here is gradual. The depth to the central axis is less than the Balance section. In order to determine whether a section is over-or-under reinforced therefore it is necessary to calculate the position of both the balanced and the actual neutral axis considering or to compare the total area of reinforcement divided by the product of width and depth with the values specified by B. S. 8110 (1995).

From the reports collected, the failure of the collapse building started from the columns. This occurred within the 30 seconds prior the collapse as the columns started twisting, wangling and buckling with the throwing of stones from the existing columns and removal of the cover provided in the columns. According to Mosley and Bungey (1982) short columns usually fail by crushing and slender column is liable to fail by buckling. If the failure started from the columns as indicated above, most of the columns must have been wrongly designed. Perhaps, all were designed as short columns. Hence, columns three and four about 25 numbers, which should have been designed as slender columns would fail by buckling. We can deduce that part of the reasons of the collapse are buckling of the columns due to overloading of the few columns provided and over-reinforcement of some of the structural members. Also, the addition of one floor to the one storey designed during construction would have some effect on the foundation base. Overloading would cause the earth pressure of the foundation base to increase and bending failure of the columns base would occur. In Table 4, all the beams checked were normally reinforced except beam eight, which was over-reinforced.
